JOURNEY
HOME INSPECTION LLC

Home Inspection Report

6538 Toweline St.

Inspected On Wed, Jun 22, 2022 at 12:49 PM

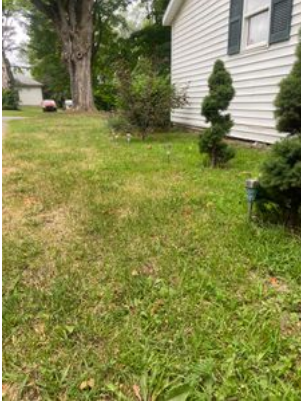
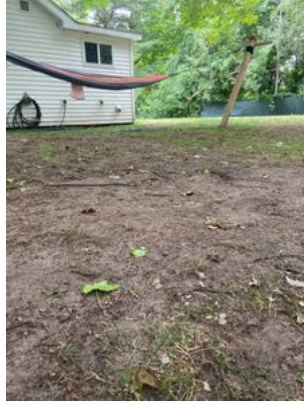
Site Grading

Sloped Away From Structure, Sloped Toward Structure

Condition: Satisfactory

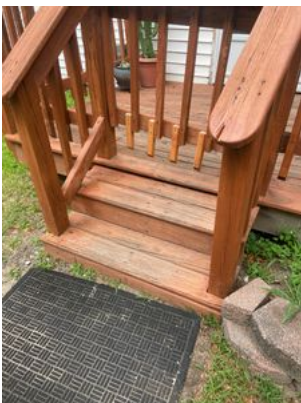
Steps/Stoops

Wood

Condition: Satisfactory

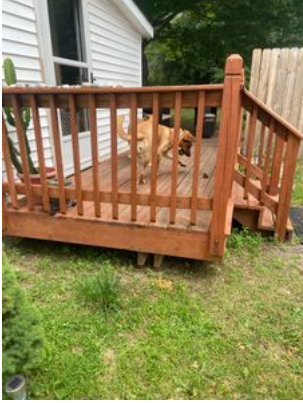
Patios/Decks

Wood

Condition: Satisfactory

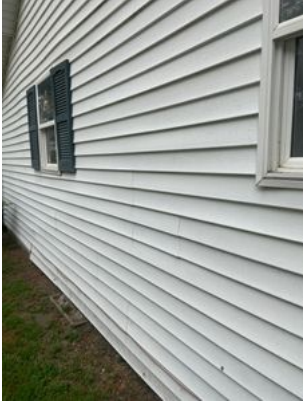
Exterior Covering

Vinyl Siding

Condition: Satisfactory

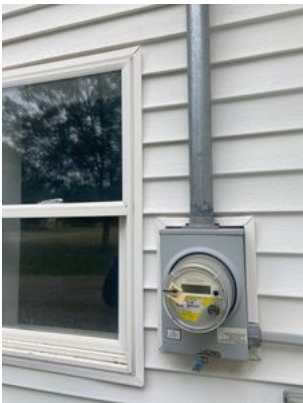
Exterior Trim Material

Vinyl

Condition: Satisfactory

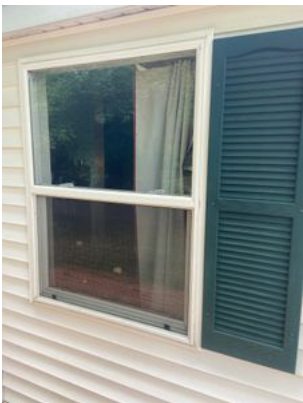
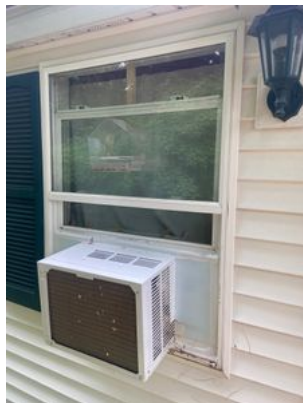
Windows

Vinyl

Condition: Satisfactory

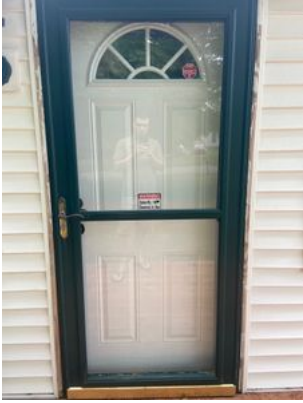
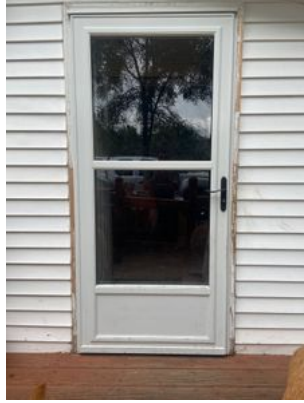
Entry Doors

Steel

Condition: Satisfactory

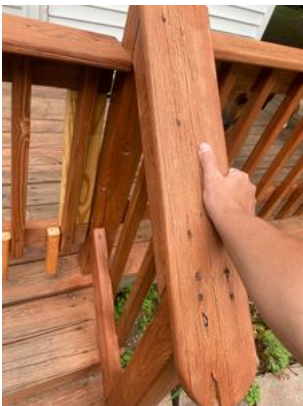
Railings

Wood

Condition: Satisfactory

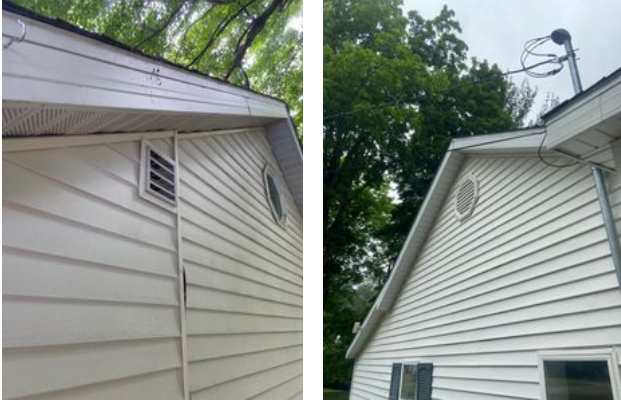
Ventilation Present

Roof, Soffit, Gable Ends, Ridge Vents

Condition: Satisfactory

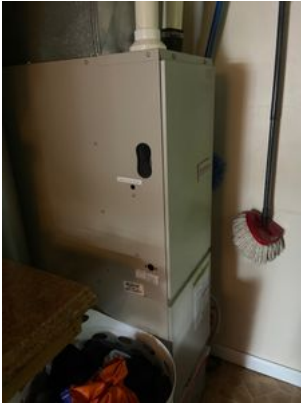
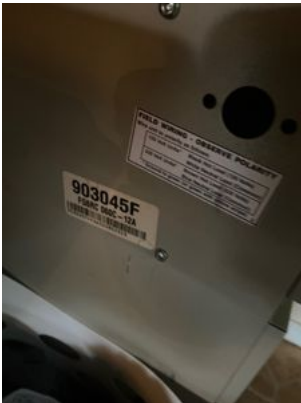
Tappan

15 years

Furnaces over 10 years old should be checked, cleaned and serviced yearly by a licensed contractor.
